Reliability of CGA/LGA/HDI Package Board/Assembly (Revision A)

JPL Publication 12-3 2/12

NASA Electronic Parts and Packaging (NEPP) Program
Office of Safety and Mission Assurance

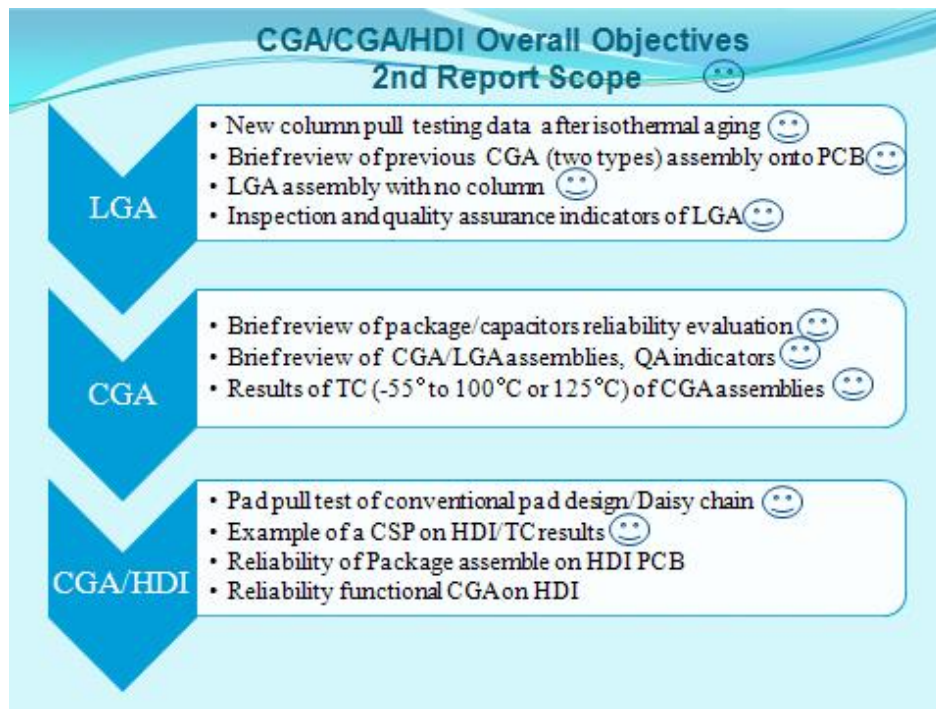
Figure 1. Test matrix for CGA/CCGA/HDI package/board/assembly program with identification of the key areas of investigation.

The overall objectives and approaches of the reliability evaluation of CGA/LGA/HDI package/board/assembly are summarized in Figure 1. Topics marked with smiley faces are investigated and either presented previously [1] or will be covered in this or follow-on reports when sufficient data become available. The overall goal is to develop qualification guidelines for advanced high input/output (I/O) column/land grid array (CGA/LGA) assembled onto both conventional and high density interconnect (HDI) printed circuit/wiring boards (PCB/PWB). This report will briefly address results for package evaluation and assembly optimization as well as detail results of thermal cycle testing and failure analyses.

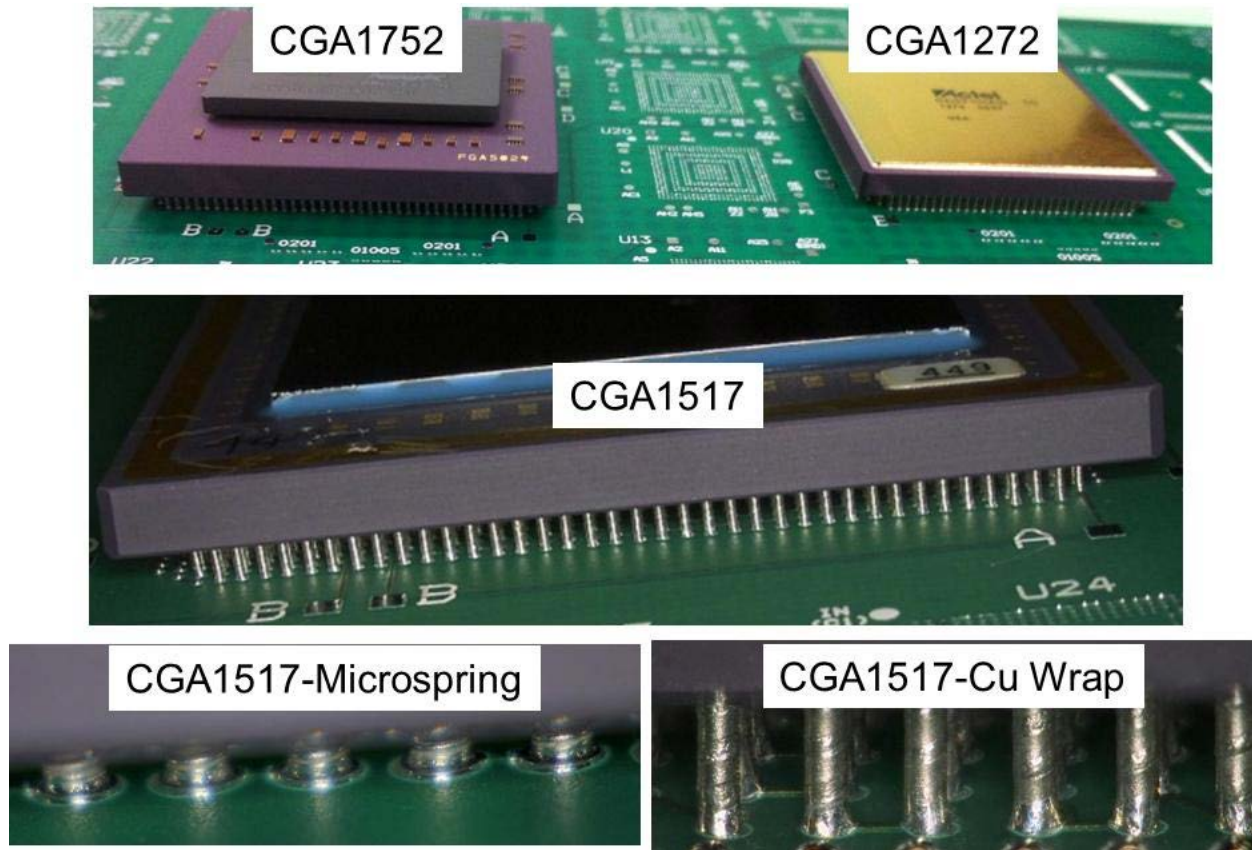
Figure 2. Four CGA types: CGA1752 with pure solder column (top-left) and CGA1272 with copper-wrapped solder column (top-right), CGA1517 with microspring column (bottom-right), CGA1517 with Cu Wrapped column (bottom-left).

Two CGA packages with 1752 and 1272 I/Os and two column styles were evaluated, one with a pure solder column and the other with a copper-wrapped solder column. The scope of evaluation also included a ceramic array package with 1517 I/Os that came as land grid array (LGA) with no column attachment. LGAs were converted into CGA by performing two styles of column attachment at two facilities. One style had copper wrapped onto a solder column with a diameter slightly lower than standard value; the other style had a microspring coil with no solder column, but a standard diameter. Figure 2 shows photomicrographs of four CGA packages and their column configurations. Integrity of the Cu-wrapped column was established with isothermal aging at 125°C for up to 1000 hours of aging.

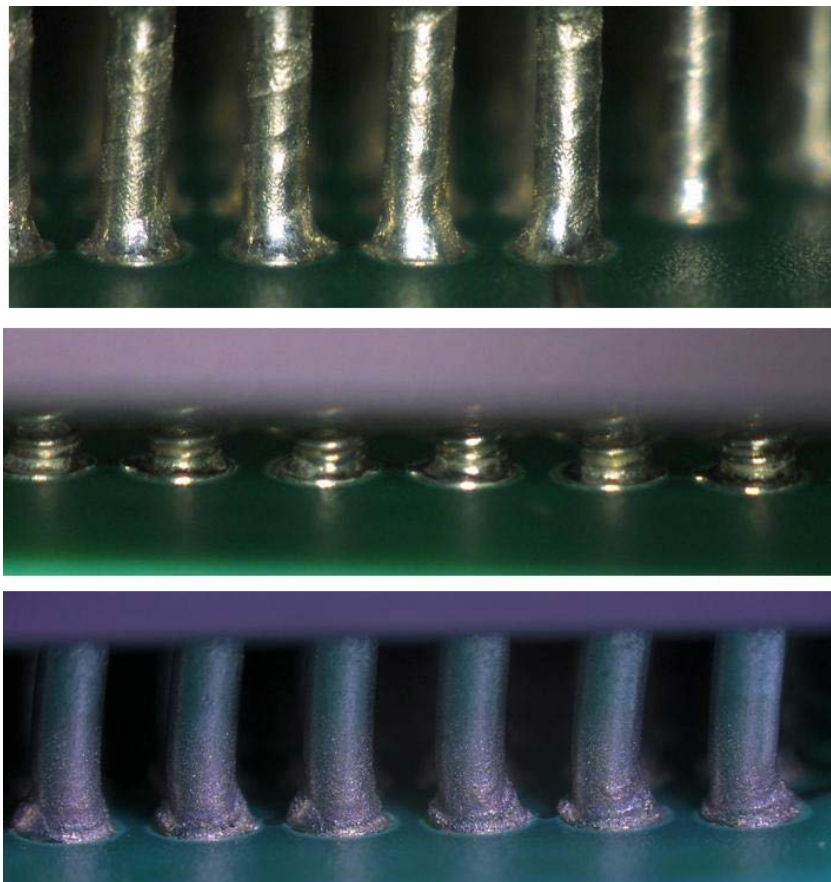
Figure 3. Representative photomicrographs of three solder columns solder joint quality after 200 thermal cycles ($-55^{\circ}/125^{\circ}\text{C}$) for CGA package assemblies.

Four CGA packages (CGA1272, CGA1509, CGA1517, CGA1752) with three column types (pure solder, copper-wrapped, and microspring columns) were assembled onto conventional printed circuit boards using three types of tin-lead solder paste alloys. The inspection results of the peripheral columns after assembly revealed that the quality of solder joints to be acceptable (see Figure 3). X-ray photomicrographs, showing the quality of solder joint assemblies and applicable workmanship defects, revealed no shorts or significant solder balling. Four types CGA assemblies were subjected to thermal cycling for evaluation of solder joints as well as capacitor and internal flip-chip die on package. Assemblies were subjected to two extreme profiles representative of use for high reliability applications. The thermal cycles ranged from a low temperature of -55°C to maximum temperatures of either 100°C or 125°C with slow ramp-up rate of $3^{\circ}\text{C}/\text{min}$ and dwell times of about 15 minutes at the two extremes. Optical, SEM, and X-ray inspection of assemblies were performed prior to thermal cycling to evaluate solder joint quality and workmanship defects and subsequent inspections during thermal cycling exposures established solder damage and progress with cycling. Photomicrographs illustrate key inspection findings after up to 200 thermal cycles are presented. Figure 3 provides examples of such

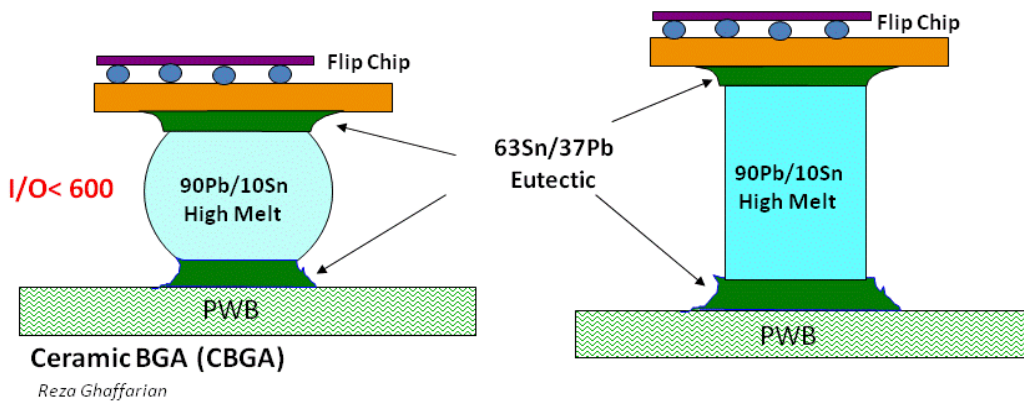
Figure 4. Examples of ceramic column grid array (CCGA or CGA) and ceramic ball grid array (CBGA) package configurations.

CGA packages are preferred to CBGA (see Figure 4) since they show better thermal solder joint reliability than their CBGA counterparts. For most high reliability applications, CGAs show acceptable solder joint reliability for larger packages and higher than 300 I/Os (when resistance to thermal cycling is significantly reduced for CBGAs with increasing package size and I/Os). To limit the growth of package size, most ceramic packages with more than about 1,000 I/Os come in the CGA style with 1-mm pitch or lower.

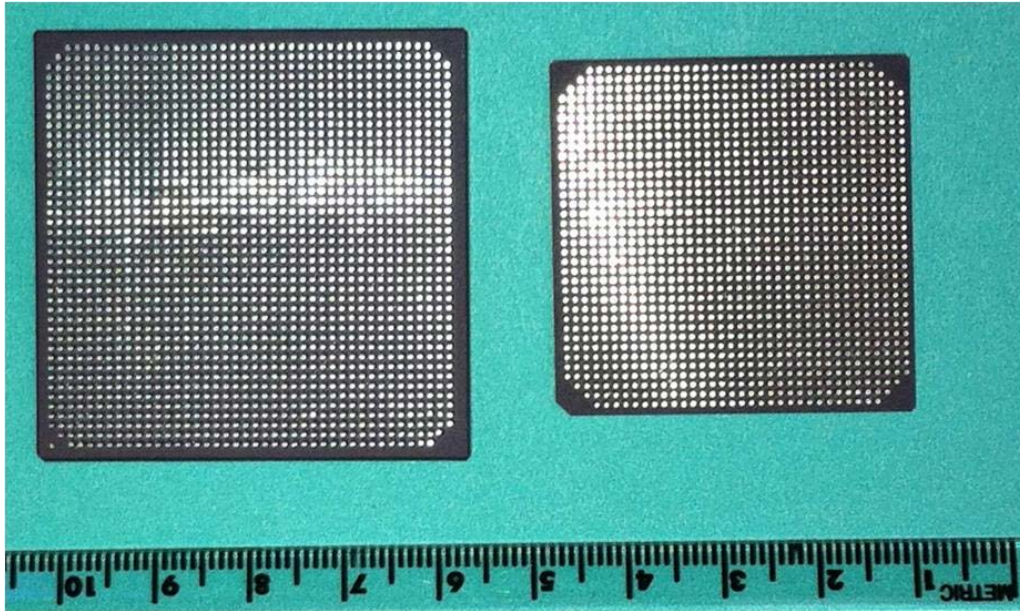
Figure 5. The two column grid array (CGA) packages; 1752 I/Os (left) and 1272 I/Os (right). Note that in both cases corner columns are removed by the manufacturer.

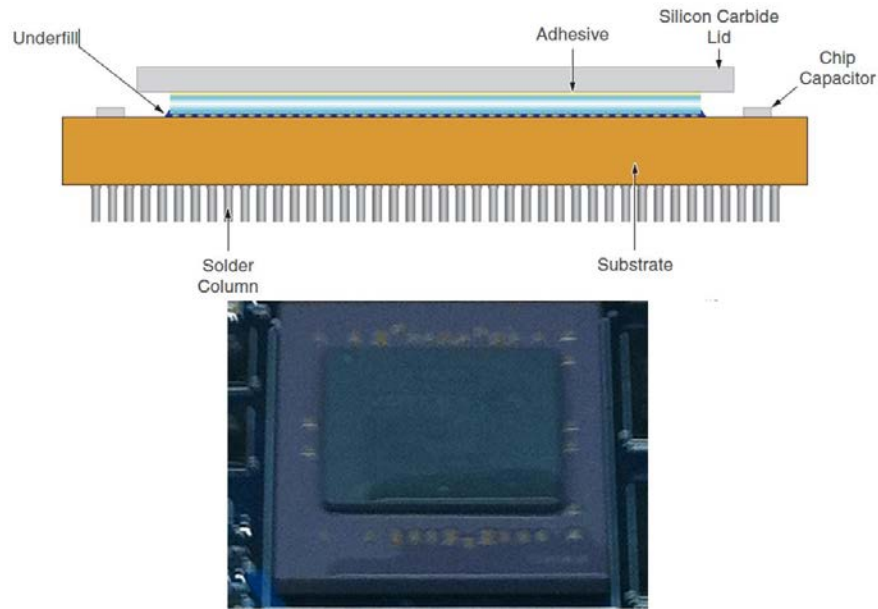
Figure 6. Construction of CGA 1752 I/O package (top) and photo of package showing the exposed chip capacitors.

The two CGA package types were inspected by microscope to detect any workmanship defect anomalies, such as bent columns, and to verify the quality and uniformity of solder joints for column attachments. (see Figure 6, for representative photomicrographs of the two packages.) The 1752 package has pure tin-lead solid solder with high lead concentration (90Pb/10Sn); the 1272 CGA package has slightly lower lead solder content (80Pb/20Sn), but solder columns are wrapped with copper helical spring. Copper-wrapped columns are also tin-lead coated and therefore do not have the appearance of copper except for the exposed flat area on top.

The CGA1272 is hermetically sealed with no additional chip capacitor parts. The CGA1752 is non-hermetic, has an additional chip capacitor on top of the ceramic substrate, and is exposed. Figure 6 shows a generic construction of this package provided by the manufacturer along with a photo of the package from the top. Inspection of chip capacitor solder joints for a package received in December 2010 revealed a number of unacceptable solder joints, based on NASA workmanship standards. For this reason, the solder joints for these chip capacitors were further characterized by SEM and subjected to a limited number of thermal shock cycles. The results of inspection and environmental evaluation are discussed in the following sections.

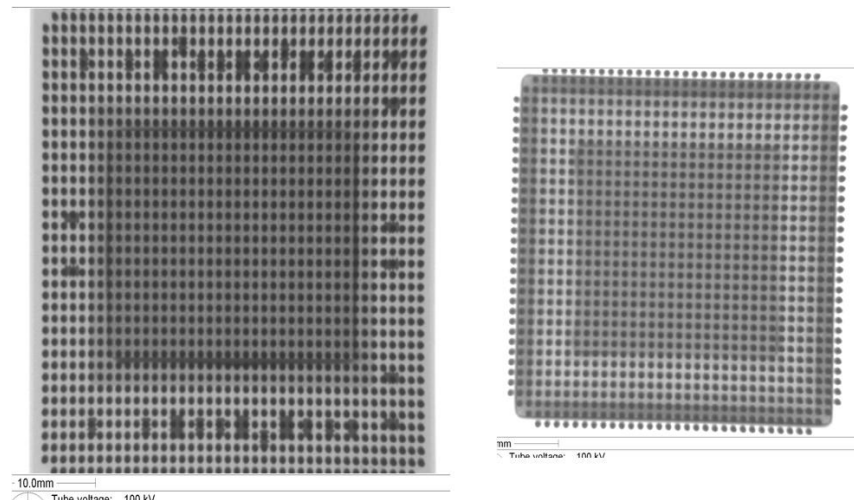
Figure 7. X-ray photomicrographs of CGA 1752 I/Os (left) and CGA 1272 I/Os (right); the darker areas are where chip capacitors are located.

A real-time 2D X-ray system was used to determine the integrity of column solder joint attachment, among other features of these packages. Figure 7 shows representative X-ray photomicrographs of CGA1752 and CGA1272.

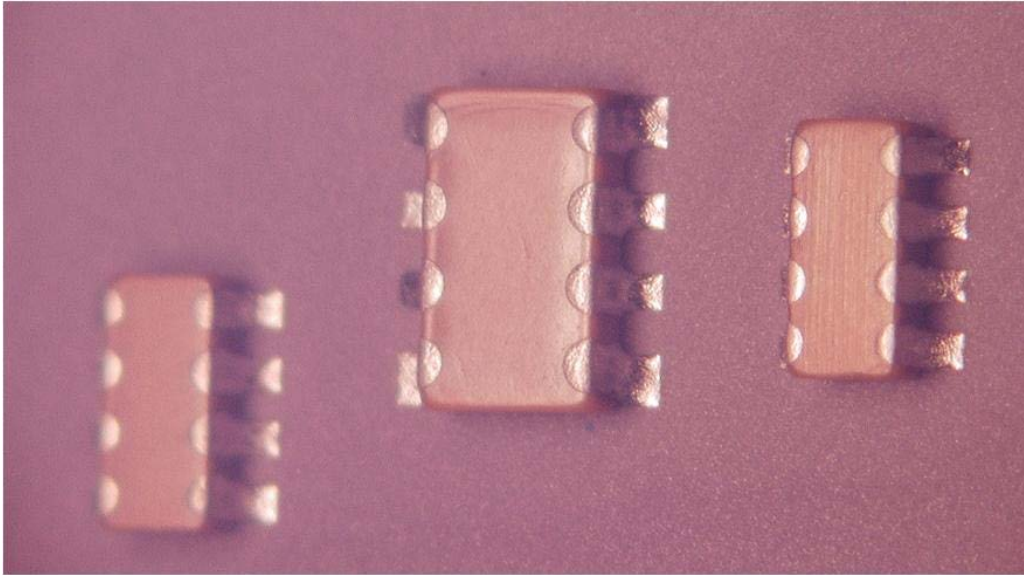
Figure 8. Chip capacitors showing better solder joint quality in the May 2011 set.

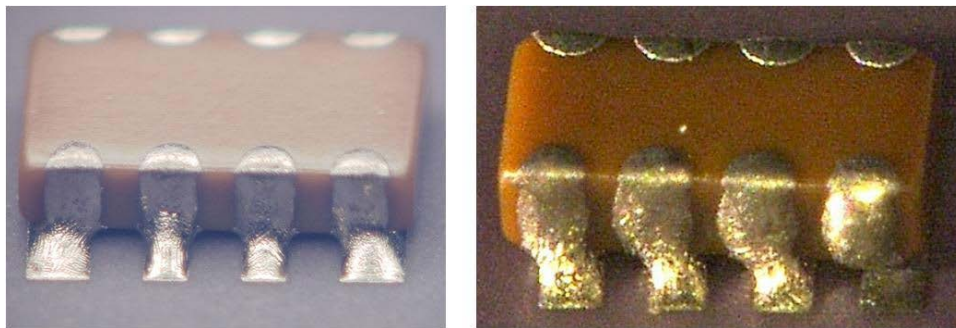
Figure 9. Chip capacitors showing inconsistency in solder joint quality; the far right solder is clearly unacceptable.

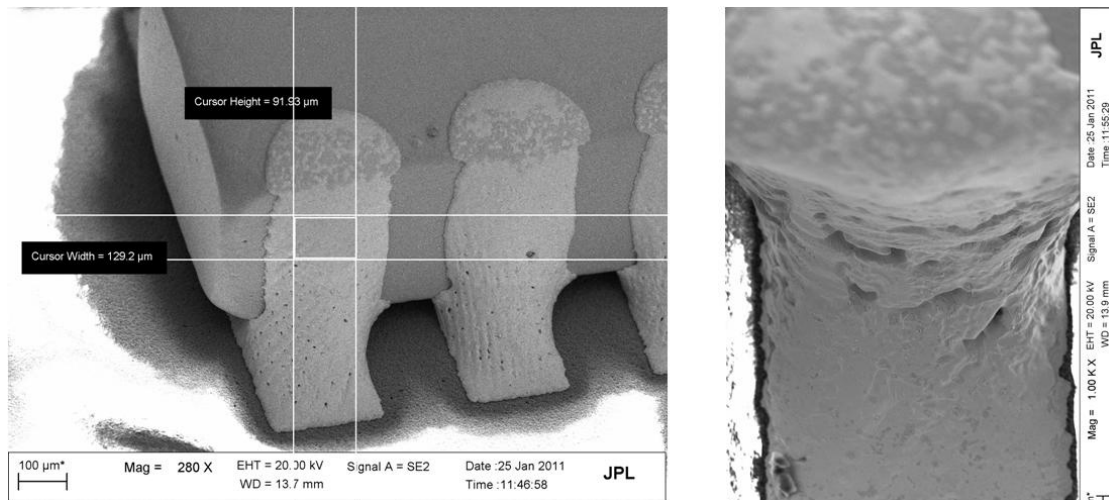
Figure 10. SEM photomicrographs showing the nature of solder joints at much higher magnification.

Further characterizations were performed using SEM to better define microstructure. Figure 10 shows a representative example of solder joint quality at a higher magnification. In addition, elemental analysis was performed using dispersive X-ray spectroscopy (EDX/EDS) to obtain semi-quantitative elemental results for the solder joints. The results showed that indeed they are high lead tin-lead solder (90Pb/10Sn), similar to the column solder alloy. The melting point of these solder alloys is higher than the tin-lead commonly used to attach columns onto PCB. High lead solders generally show a lack of shininess and

poor flow. This is due to their alloy pasty regime during solidification when they are compared to eutectic tin-lead solder, with no pasty regime during melting.

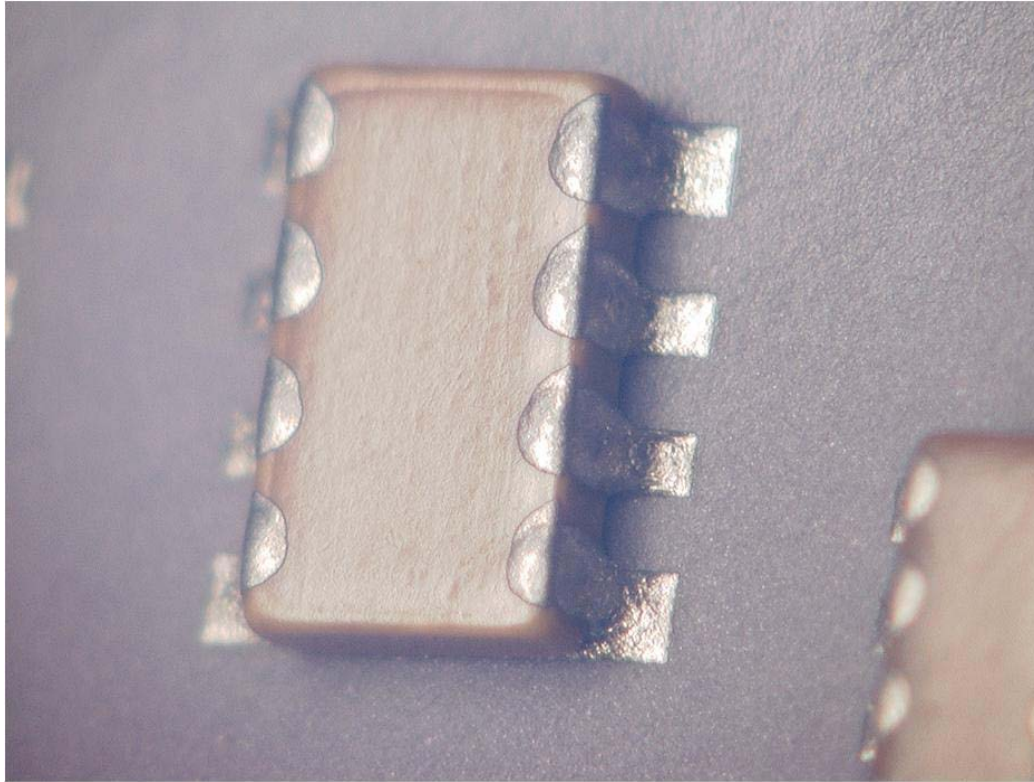
Figure 11. Chip-capacitor solder joint quality after 200 thermal shocks (-55° to 130°C) showing no signs of cracks.

Figure 11 shows representative solder joints after 200 thermal shock cycles. No evidence of significant damage or crack initiation was observed. Resistance of solder joint to thermal shock is attributed to good coefficient of thermal expansion (CTE) match of ceramic chip capacitors to ceramic CGA substrate. The higher melting temperature of high lead (tin-lead alloy) solder also contributed to its high resistance to thermal shock cycle.

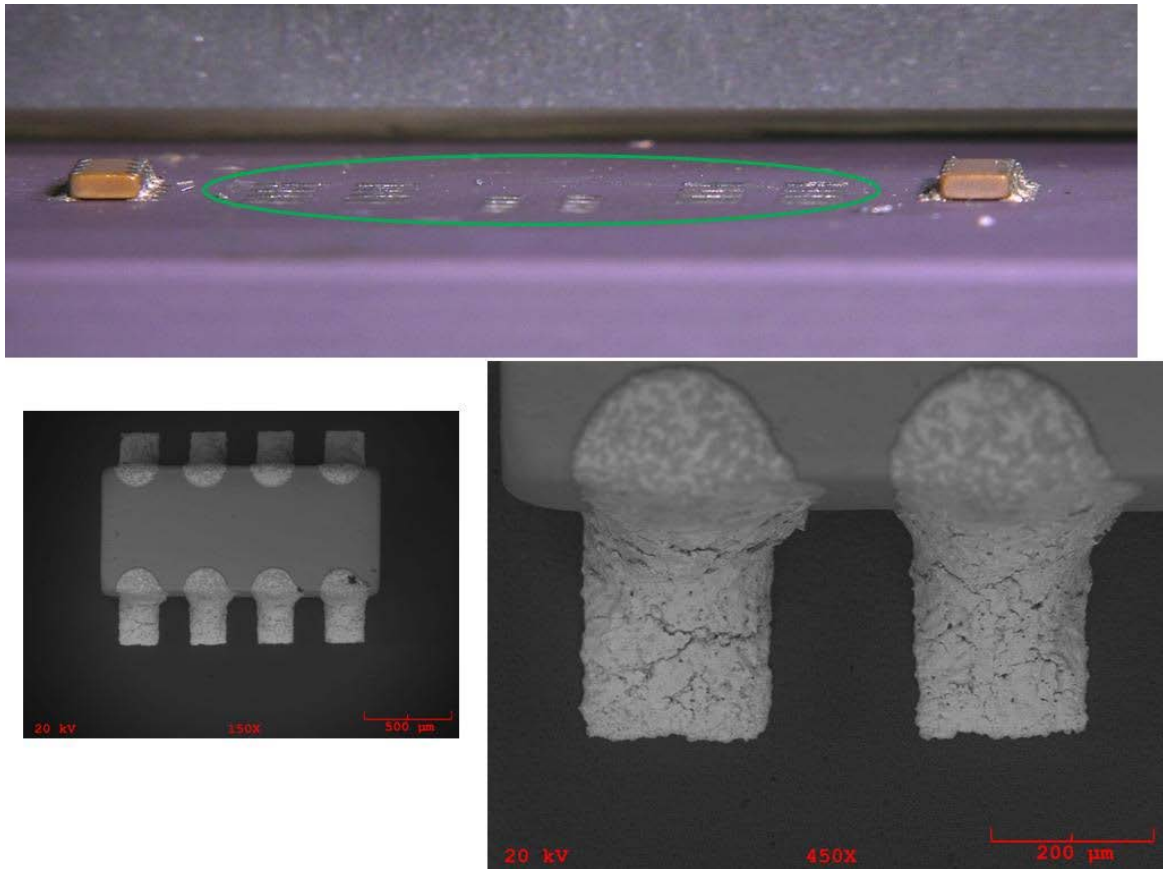
Figure 12. SEM photomicrographs of chip-capacitor solder joint quality after an assembly reflow cycle (RT-218°C) and thermal cycles (–55° to 125°C) and removal locations.

The unassembled CGA1752 package after thermal exposure was also assembled onto PCB along with the other unexposed packages using eutectic tin-lead solder joint. This and other package assemblies were subjected to thermal cycling using two profiles. The chip capacitors with pre-cycling condition were inspected while on the substrate using optical and SEM. Damage condition of a representative chip capacitor after CGA assembly thermal cycling prior to removal and locations of their removal for subsequent evaluation is shown in Figure 12. The history of thermal cycle condition of these chip capacitors is as follows:

- Package subjected to thermal shock ($-55/130^{\circ}\text{C}$);
- Reflow for Assembly (218°C); and
- Additional TCs of CGA package assembly on board.

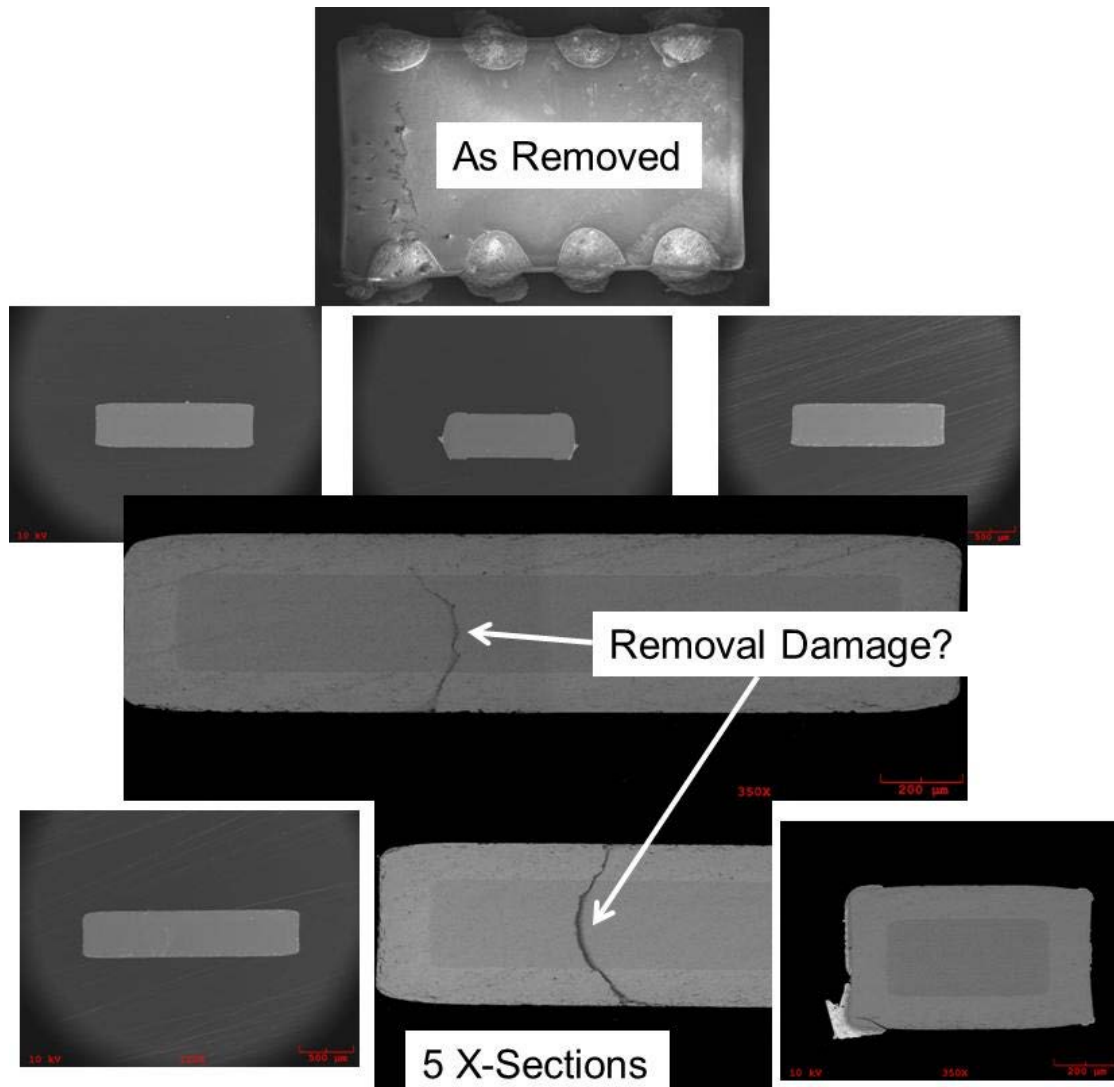
Figure 13. SEM photomicrographs of five chip-capacitor before (top) and after cross-sectioning (five) subjected an assembly reflow cycle (RT-218°C) and thermal cycles (–55° to 125°C).

SEM features of a removed capacitor shows signs of large number of microcracks and gross microstructural features. Cross-sections (see Figure 13) of chip capacitor showed no internal failures even though one showed cracking through section possibly due to methods of removal of chip from substrate by mechanical means. Option of de-soldering of solders for capacitor removal was not considered since it is thought that such thermal shock could cause formation of internal microcracks or failure, which would have been difficult to distinguish from the induced environmental thermal shock or thermal cycle testing.

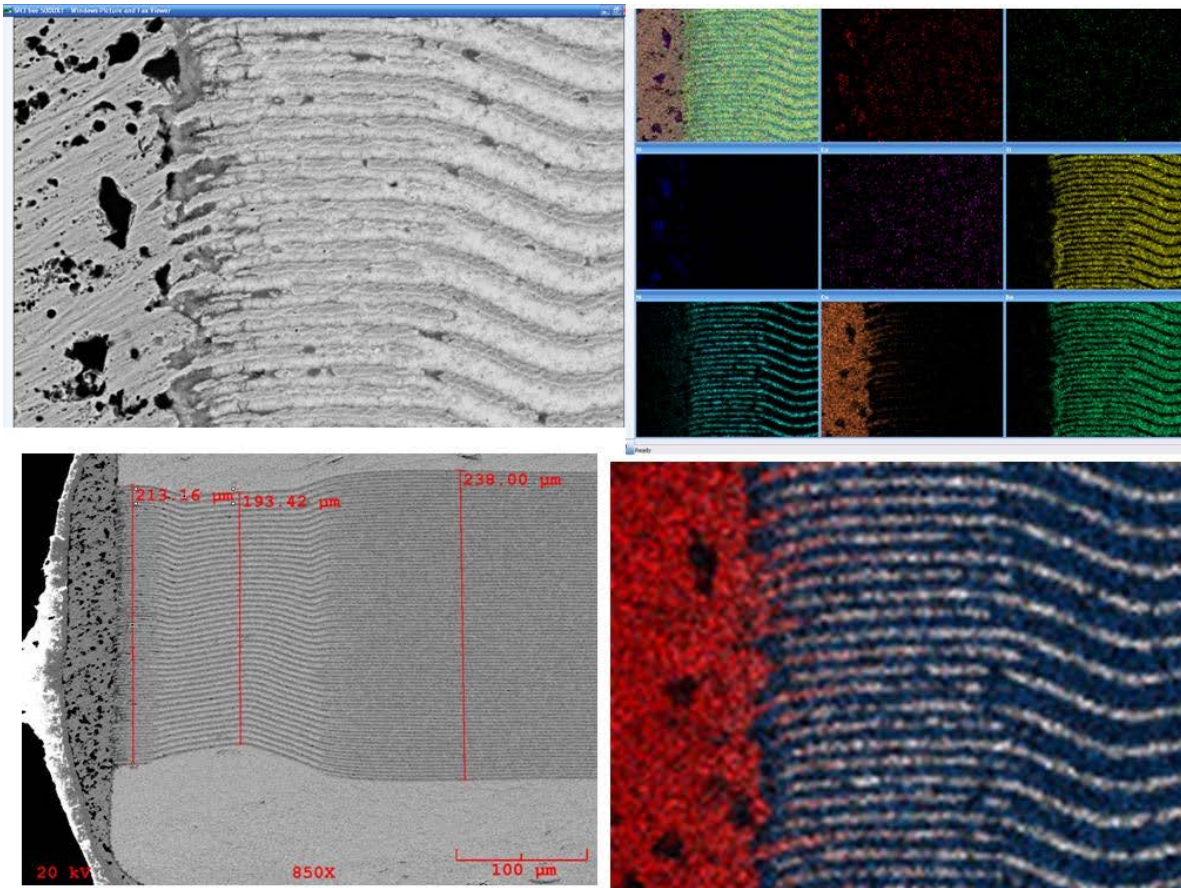
Figure 14. SEM photomicrographs of chip-capacitor showing EDS elemental analysis of layers and end cap as well as dimensions of those layers

SEM EDS elemental analysis and mapping for capacitor's interlayer chemical distribution are shown in Figure 14. Capacitor was identified as BaTiO_3 dielectric with Ni electrodes. BaTiO_3 capacitor is part of category of capacitors that are known as base metal electrode (BME) which were developed to meet the needs of microelectronic industry for reduction in cost, demand in increasing capacitance, and move towards shrinking in size.

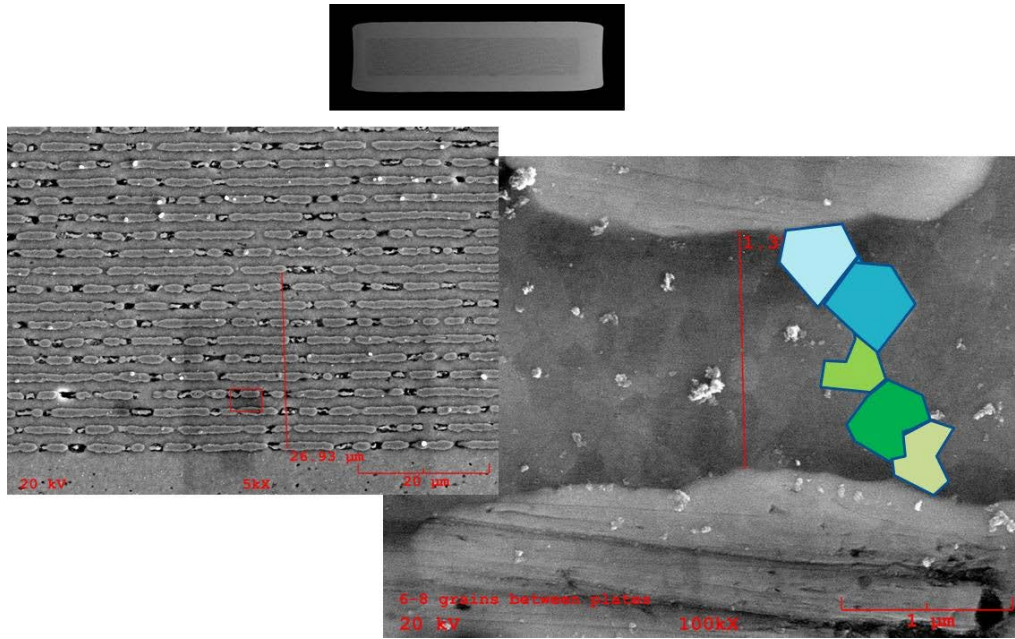
Figure 16. SEM photomicrographs of cross-section of a chip-capacitor showing layers and grain size distribution of BaTiO₃. Colors are traces of grain boundary to delineate grain sizes.

The metallographic mount of chip capacitors, which had been removed from thermal cycled assemblies of CGA1752, were further polished in order to reveal grain microstructure. It is reported [7] that grain microstructure and size play an important role on capacitor reliability. Figure 16 shows an example of the thermal cycled BME capacitor layering at high magnifications to delineate grain size. To further emphasis grain structure, a number of grains were roughly traced since contrast between grains is low and it may be difficult to distinguish them when viewed in the SEM photomicrographs. Based on the scale given on the bottom of photomicrographs, grain sizes are in tenth of micron in length whereas the layers are in order of micron in thickness.

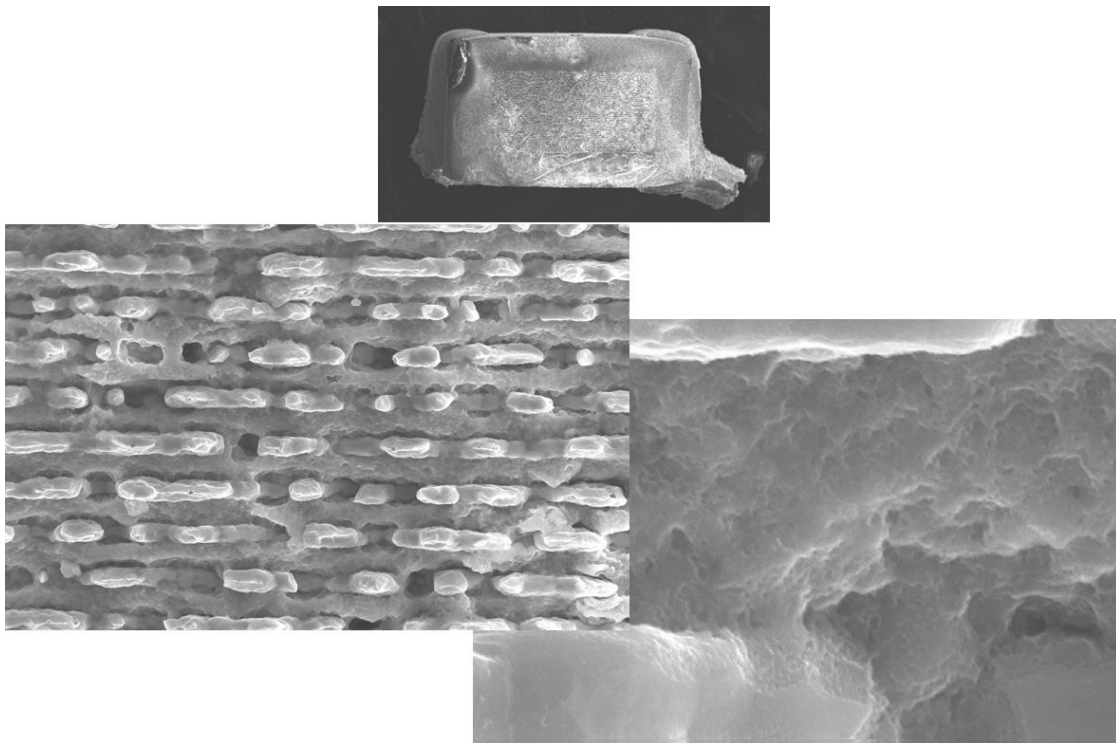
Figure 17. SEM photomicrographs of fracture surface of a chip-capacitor showing layers and indistinguishable grains of BaTiO₃.

Another approach for revealing microstructure is to fracture capacitor and then perform SEM analysis on the fractured surface. Even though excellent contrast was achievable in the fractured surface (see Figure 17), etching of surface for this sample was not sufficient to reveal the grain microstructures.

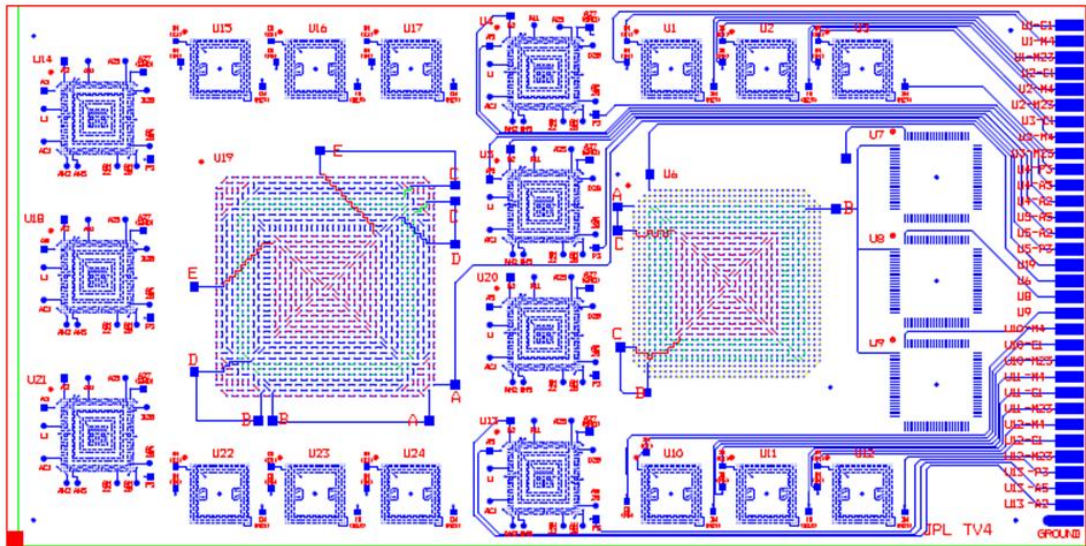
Figure 18. Test vehicle design showing both combined package and board daisy-chain patterns for the two CGA packages. A few other daisy-chain patterns currently not used for evaluation are also apparent in the design.

A complex PCB was designed to accommodate the two CGA packages and also to provide sites for other advanced fine-pitch array and leaded/no-lead packages. Figure 18 shows the board design, with daisy-chain pattern, and how traces are routed to the edge of the board for daisy-chain monitoring.

- The CGA1752, with 1.0-mm pitch and 42.5-mm² body size, designed with enough space for rework evaluation at one side. Numerous daisy chains were designed on board to complement daisy chains on a package, in order to generate complete chains for solder joint failure monitoring. Probe pairs were added near packages to monitor subdivided daisy chains.

- The CGA1272, with 1.0-mm pitch and 37.5-mm² body size, designed with enough space for rework evaluation. Lead parts are designed to determine the influence of rework visually. Numerous daisy chains were designed on board to complement daisy chains on a package, in order to generate complete chains for solder joint failure monitoring. Probe pairs were added near packages to monitor subdivided daisy chains.

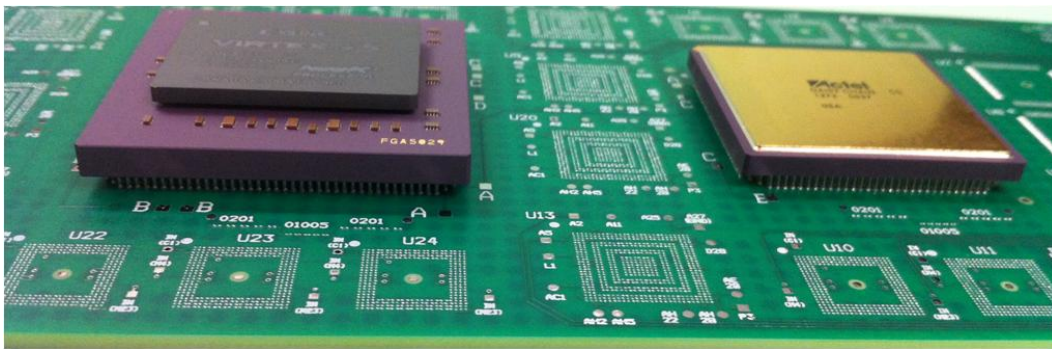
Figure 19. Assembled test vehicle showing the two CGA packages with different sizes and column styles.

These assemblies were first subjected to inspection and daisy-chain continuity checks to determine manufacturing robustness of various package configurations. Figure 19 shows an assembled test vehicle. They will be then exposed to a number of environmental conditions to evaluate their reliability and failure mechanisms. Both the paste print quality evaluation and also inspection after assemblies are discussed below.

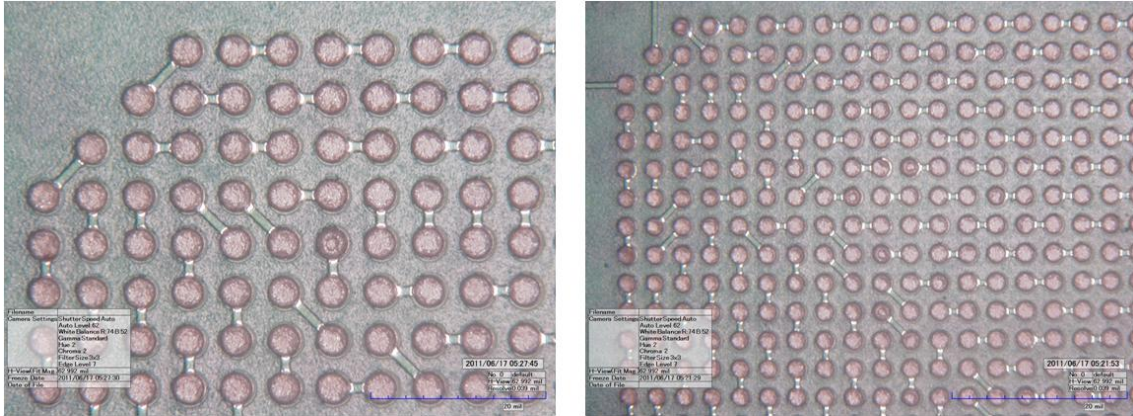
Figure 20. Representative photomicrographs of paste print deposition quality for the CGA1272 I/O (left) and CGA1752 I/O (right).

The rule of thumb for an aperture opening size is to be about four to five times the solder powder diameter. After deposition, each paste print was visually inspected using a microscope for detecting gross defects, such as bridging or insufficient paste deposition. On extremely rare occasions, print quality was improved by either adding a small amount of solder paste when insufficient paste was detected or by removing solder paste from the connecting pads when bridging was discovered. Figure 20 shows representative photomicrographs of paste print and quality for the CGA1272 and CGA1752 I/O packages. Note the daisy chain pattern on board that complements the packages.

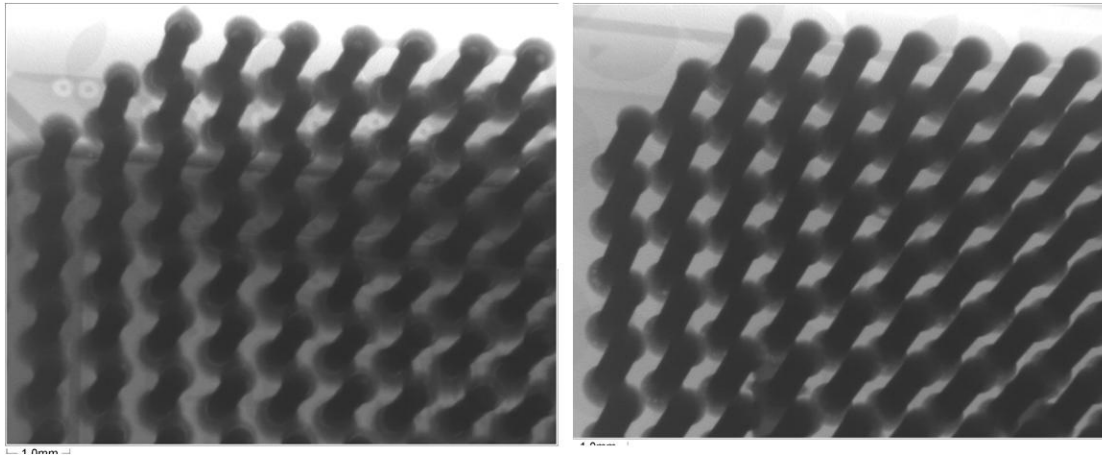
Figure 21. As-assembled X-ray photomicrographs for the CGA1272 I/O (left) and CGA1752 I/O.

X-ray inspection was performed, following visual inspection and the daisy-chain continuity check, to selectively verify package/assembly conditions. The 2D real time X-ray transmission system with oblique angle views was utilized for this inspection. Figure 21 shows representative X-ray photomicrographs for the CGA1752 and CGA1272 packages after assembly.

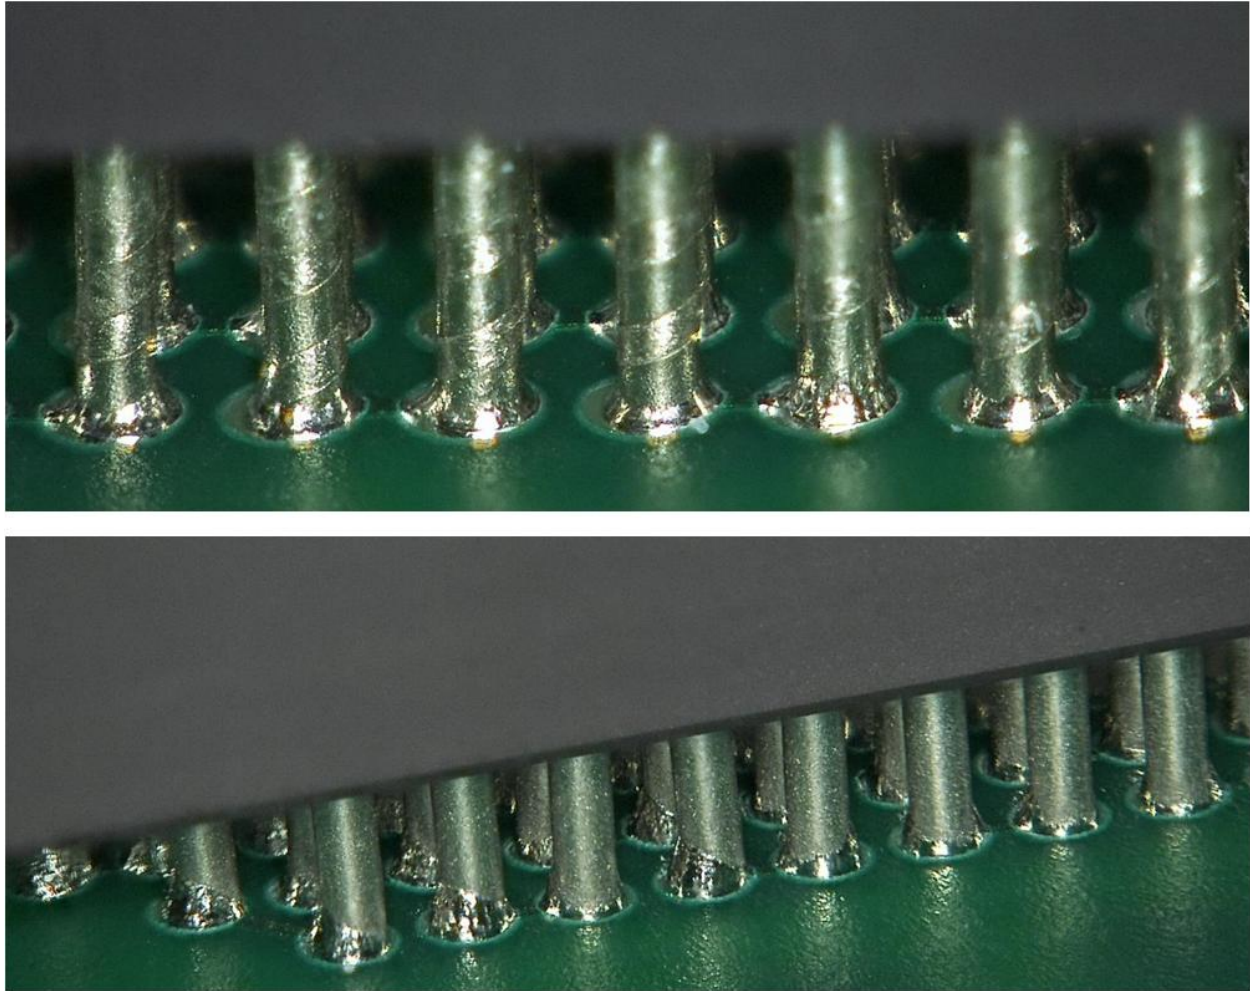
Figure 22. Representative photomicrographs of solder joint quality after assembly for CGA1272 (top) and CGA1752 (bottom).

Visual inspection of peripheral columns was performed for most assemblies, since the board was designed for visual characterization (most of the PCBs were only populated with CGAs). Only outer row, and in some cases, second and third rows could be assessed for solder joint quality. The representative photomicrographs in Figure 21 show the quality of solder joints for CGA1752 and CGA1272 I/O assemblies. Note that solder joint fillet formations are different for the pure column and copper-wrapped solder columns. Solder joints were generally acceptable even though they appear different solder wetting configuration and solder coverage of column periphery.

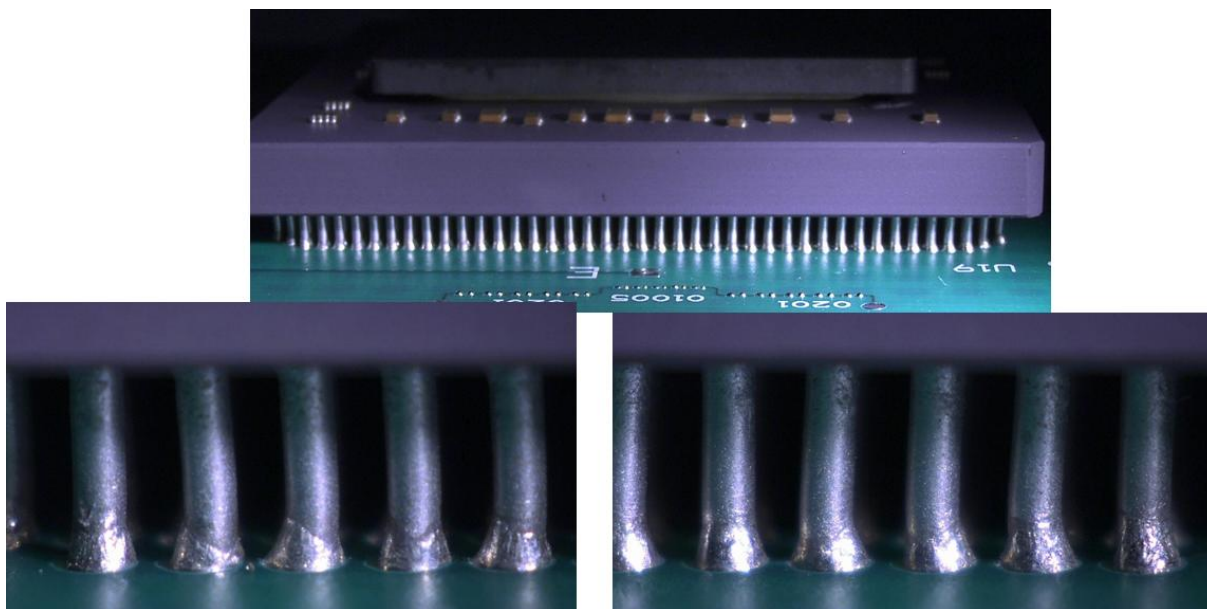
Figure 23. Representative photomicrographs of solder joint quality after 100 thermal cycles ($-55^{\circ}/100^{\circ}\text{C}$) for CGA1752.

Damage progress with thermal cycling was established using an optical microscope. Figures 23–25 present representative photomicrographs of solder joint condition and damage progress due to thermal cycling in the range of –55° to 100°C up to 200 cycles. Damage due to thermal cycling, noticeable from these photomicrographs, can be categorized as follows:

- CGA1752 with high lead solid-solder columns showed partial solder joint coverage of column perimeter with good wetting on the coverage area. Several displaced columns showing a larger corner column shift are apparent. Some column distortions were observed, signs of graininess of solder joints also observable at 200 thermal cycles. In addition, slight apparent column shifts due to shear-induced deformation due to CGA/PCB CTE during thermal cycling.

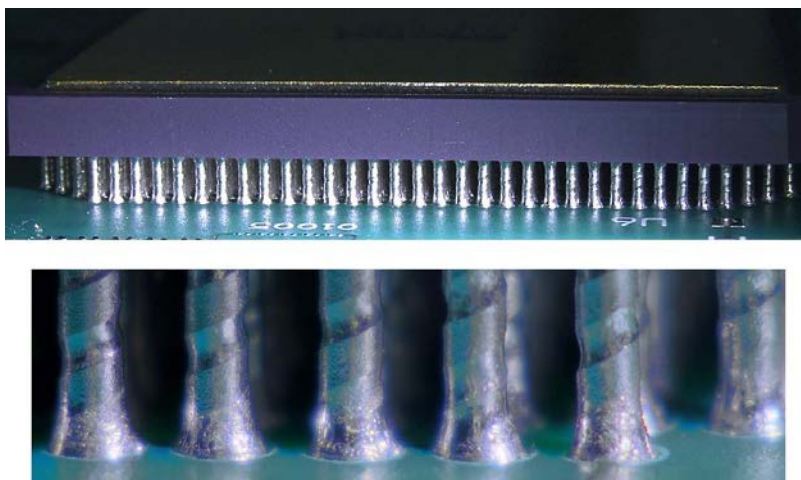
Figure 24. Representative photomicrographs of solder joint quality after 100 thermal cycles ($-55^{\circ}/100^{\circ}\text{C}$) for CGA1272.

- CGA1272 with Cu-spiral column showed good solder joint uniformity and wetting, concave solder surrounding columns. Minimum solder damage was detected due to 100 thermal cycles that slightly increased at 200 cycles; solder/columns showing signs of graininess representing tin-lead solder grain growth due to exposure at 100°C during thermal cycling. Column distortions were minimal, except for graininess of solder exposed between the Cu wrap at 200 thermal cycles. In addition, no apparent column shifts due to shear-induced deformation due to CGA/PCB CTE during thermal cycling.

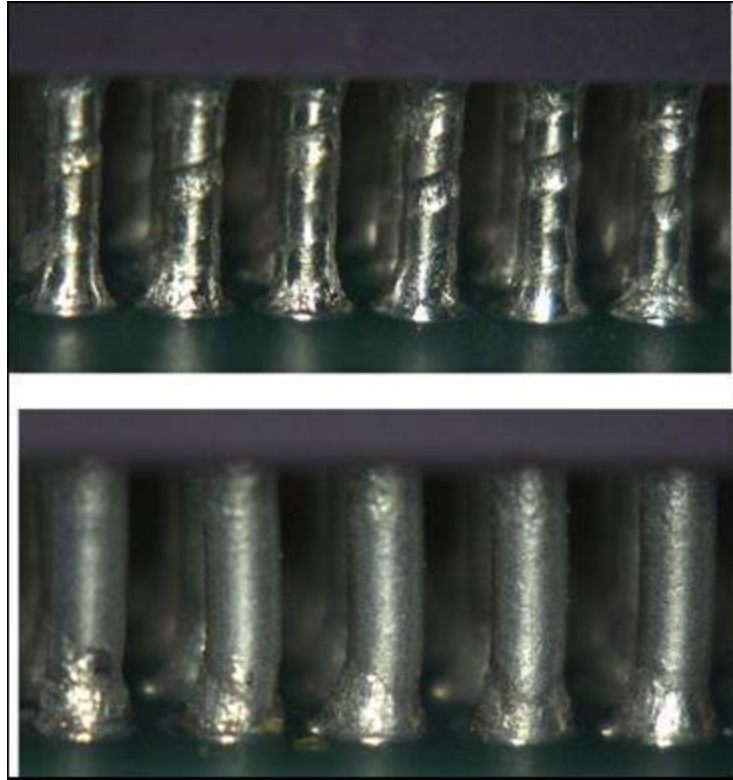
Figure 25. Representative photomicrographs of solder joint quality after 200 thermal cycles ($-55^{\circ}/100^{\circ}\text{C}$) for CGA1272 (top) and CGA1752 (bottom).

In general, less deformation occurred due to thermal cycling to 200 cycles for CGA1272 having lower package size and high column rigidity due to Cu wrap— both factors cause to induce lower thermal stress on solder joint attachment— compared to larger CGA1752 package assembly with no strengthening Cu wrap.

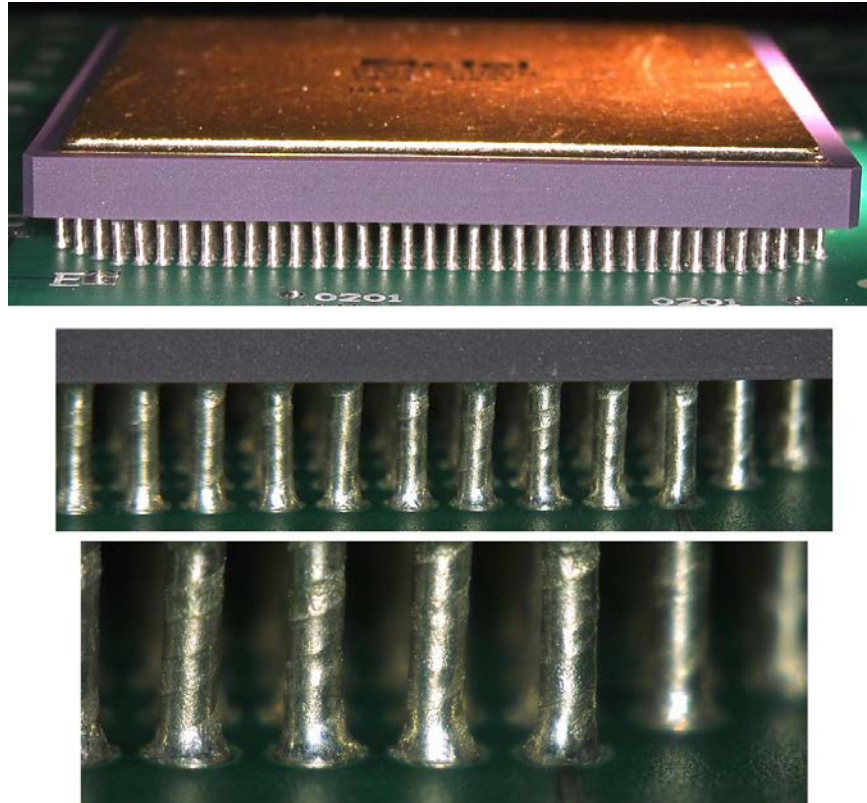
Figure 26. Representative photomicrographs of solder joint quality after 200 thermal cycles ($-55^{\circ}/125^{\circ}\text{C}$) for CGA1272.

Visual inspection was performed to establish damage progress of outer columns of CGAs at thermal cycling intervals by optical microscopy. Figures 26–27 present representative photomicrographs of solder joint condition and damage progress due to thermal cycling in the range of -55° to 125°C at 200 cycles. Damage due to thermal cycling, noticeable from these photomicrographs, can be categorized as follows:

- CGA1272 with Cu spiral column showed good solder joint uniformity and wetting. Some solder damage at 200 cycles showing signs of graininess representing of tin-lead solder grain growth due to exposure at 125°C during thermal cycling. Column distortions were minimal, except for signs of graininess of solder between Cu wrap, at 200 thermal cycles with no apparent column shifts due to thermal cycling.
- CGA1752 with high lead solder column showed partial solder joint coverage of column perimeter and good wetting on the coverage area. Several displaced columns showing a larger corner column shift are apparent. Magnified photomicrographs of corner columns clearly show signs of damage and even microcrack formation. Damage is much more severe when compared to previous thermal cycle condition with 100°C maximum TC.
